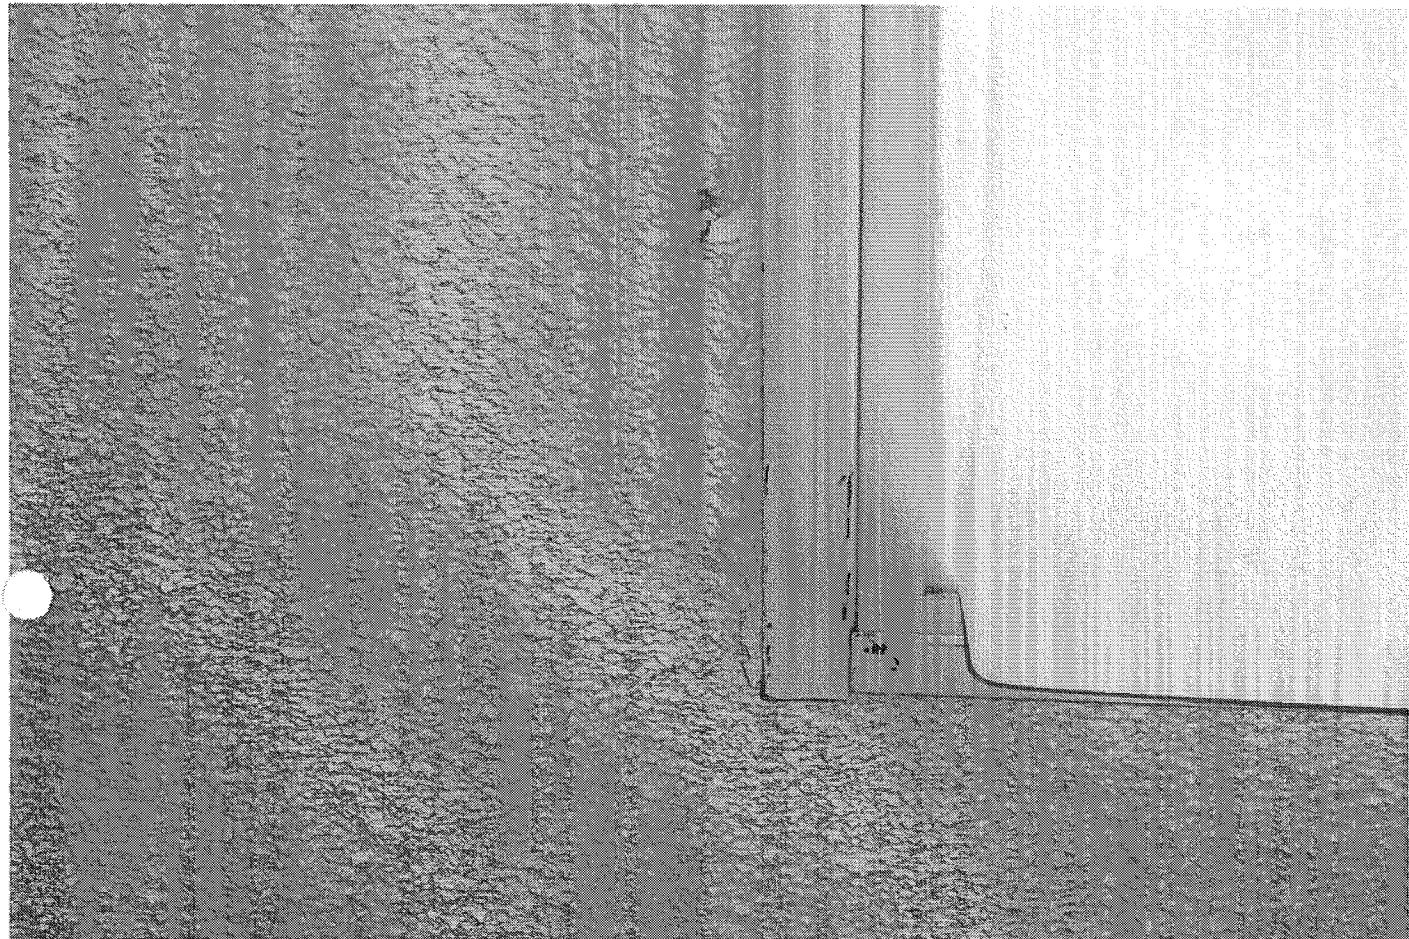
122. Back hallway at office area - Damage to acoustical plaster ceiling at corner of light fixture

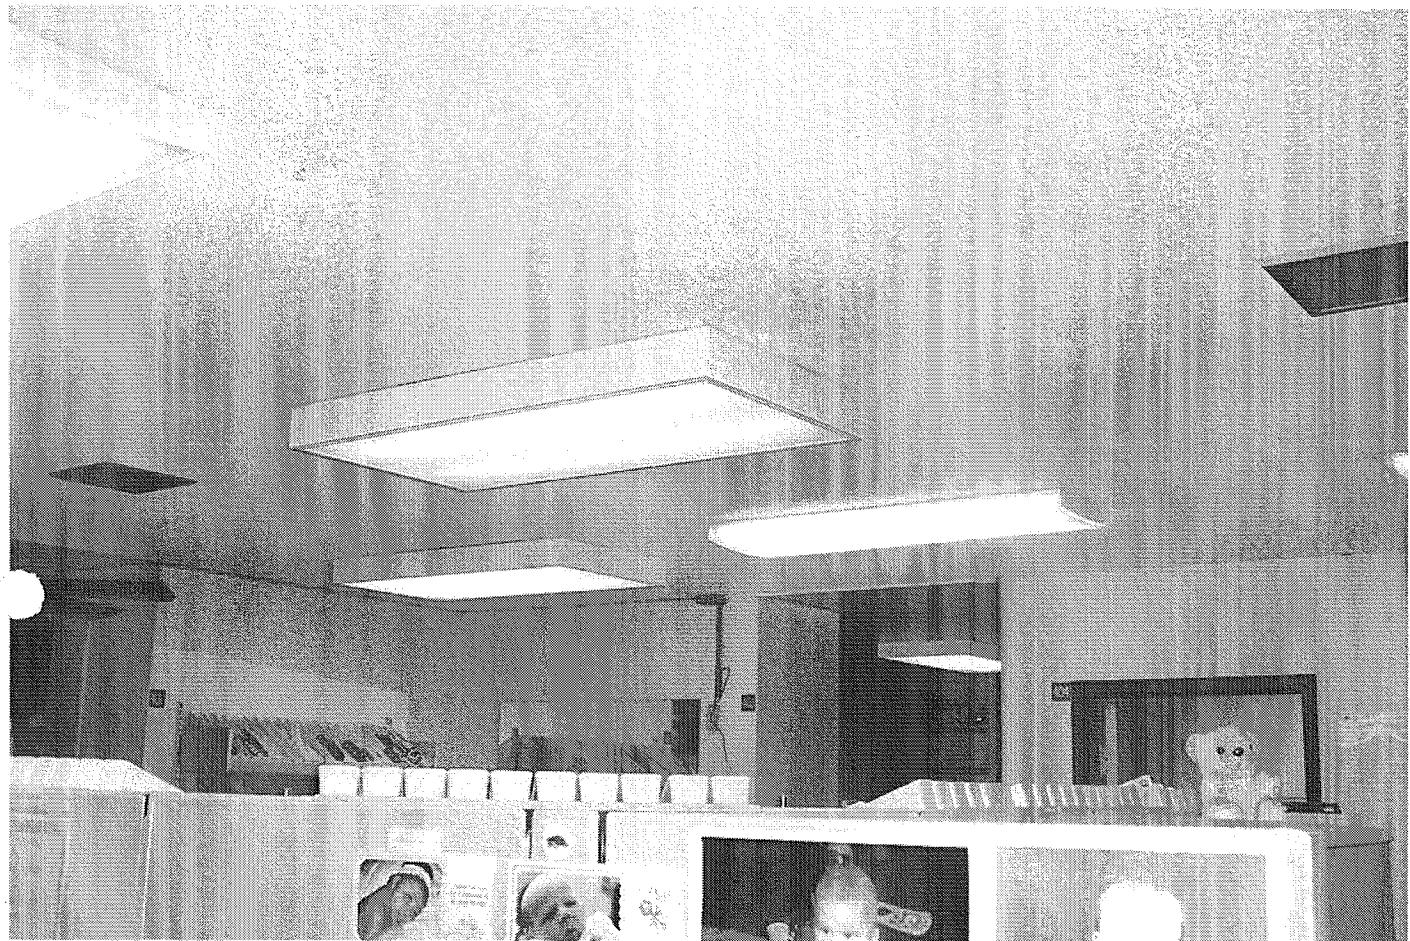
123. Back hallway at office area - Damage to acoustical plaster ceiling above reception area

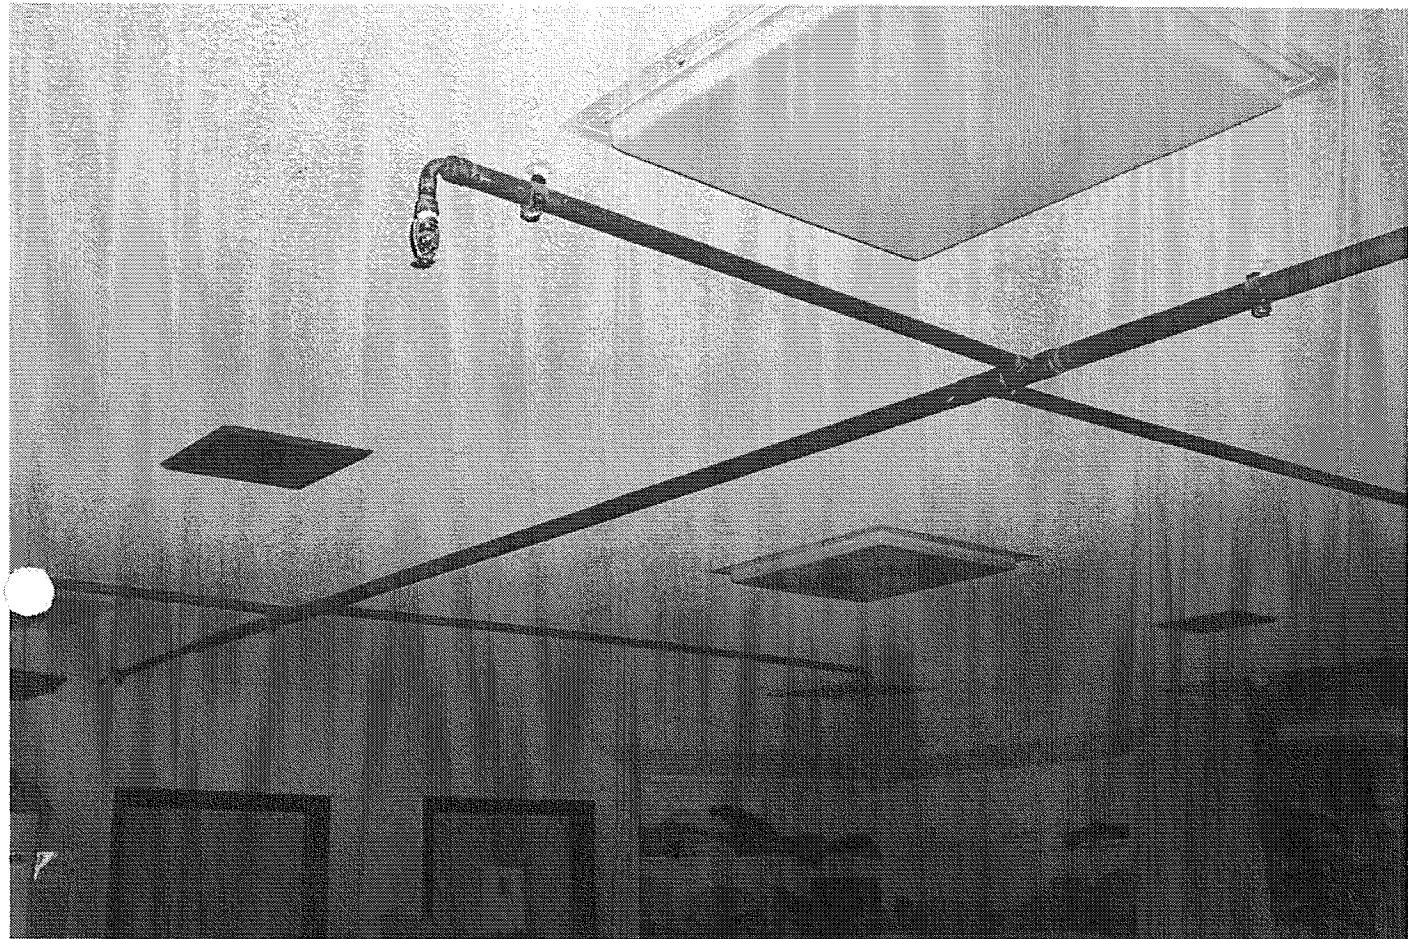
125. Upper patient area - Sprinklers attached to acoustical plaster ceiling
